CAMBRIDGE CITY COUNCIL

Air Quality Monitoring Mill Road, Cambridge

AQ Mesh Assessment

December 2021

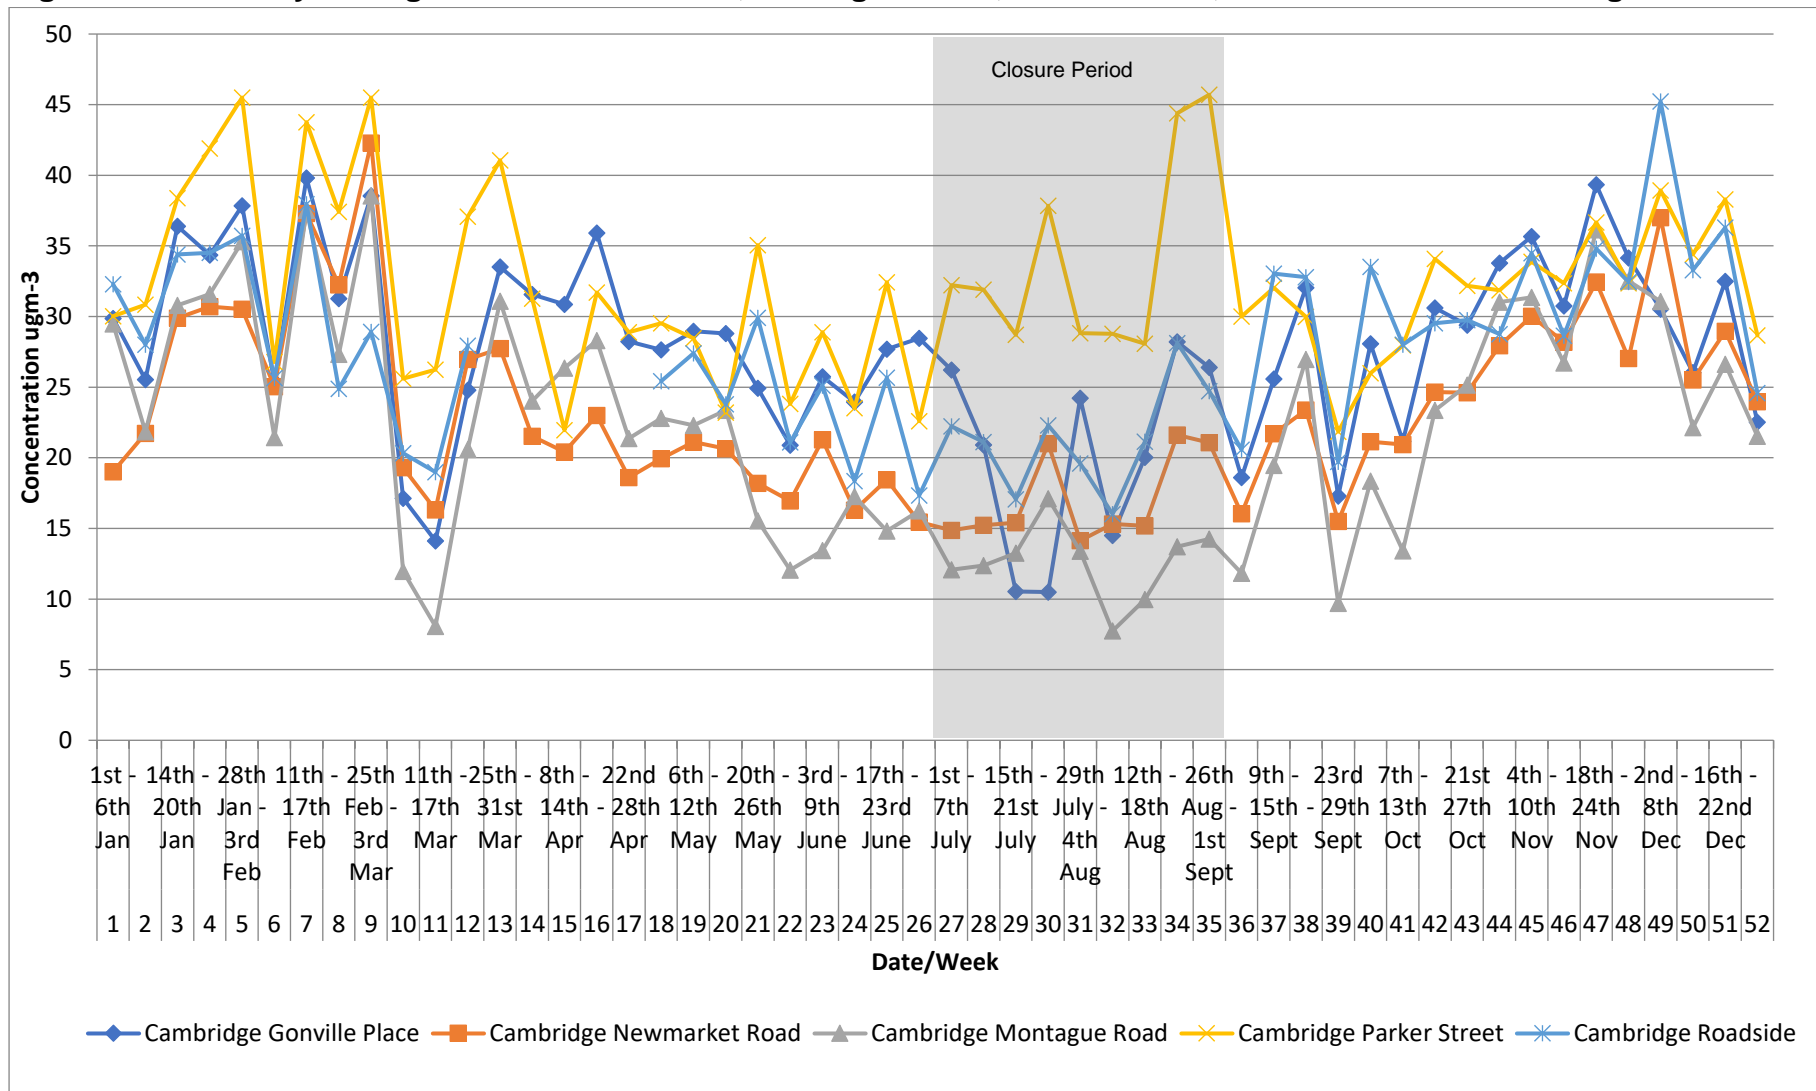
Figure 3.1 Weekly average NO₂ Gonville Place, Montague Road, Parker Street, Newmarket Road and Regent Street 2019

The monitor at Gonville Place does not show a peak in NO₂ concentrations during the third week of the road closure as shown by the other continuous monitors. This is due to a loss of data at this monitor as there was an issue with the air conditioning unit at this site. The air conditioning unit failed due to a period of extremely warm weather when Cambridge recorded the highest temperature in the UK. This is explored in more detail in Appendix B.

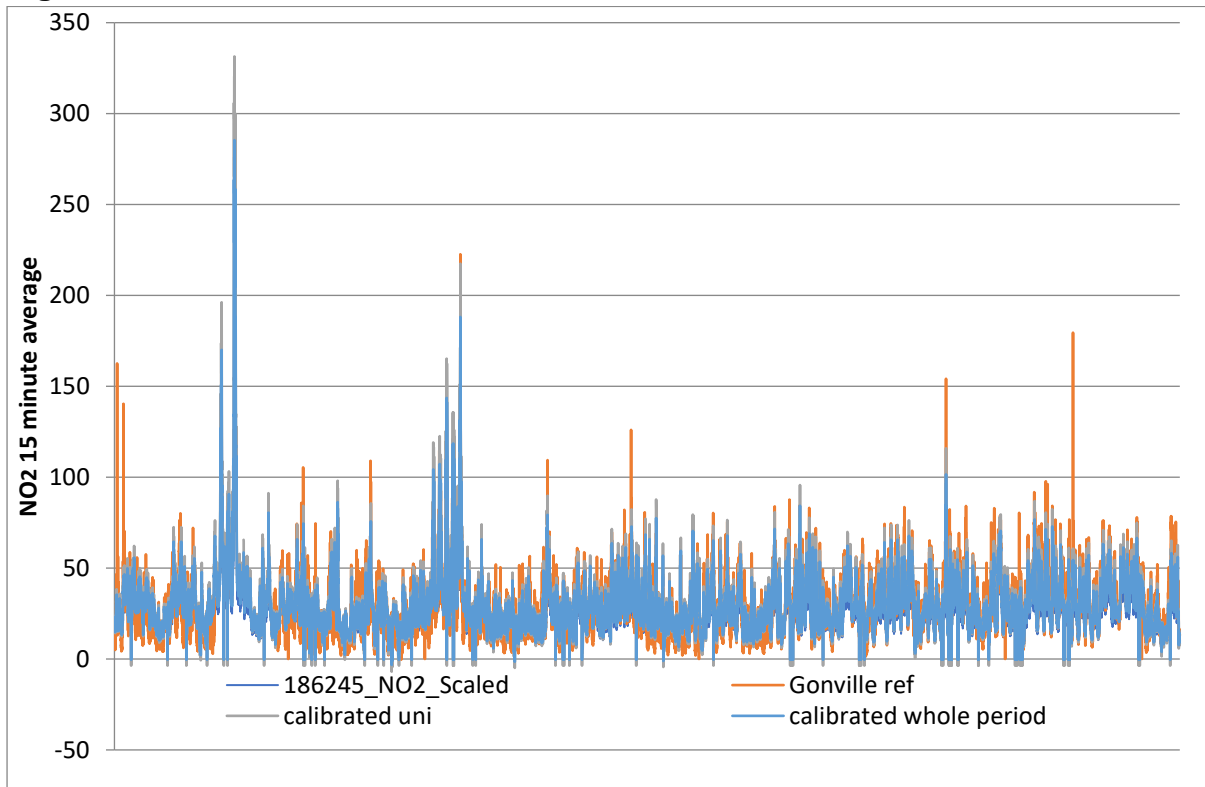
Figure B7 NO₂ calibration methods

Given the above data and discussion there were two values which we could use to calibrate the monitor using the 'classic method' - where we compare the data with the continuous monitor for the whole period. The following figure shows the values obtained from using the whole data set and the short period as recommended by the University.

The graph shows that the calibration methods both improve the results given by the AQ Mesh. There is more variability within the Gonville reference monitor results than the AQ Mesh and the calibration does take out some of the variability in the AQ Mesh results.

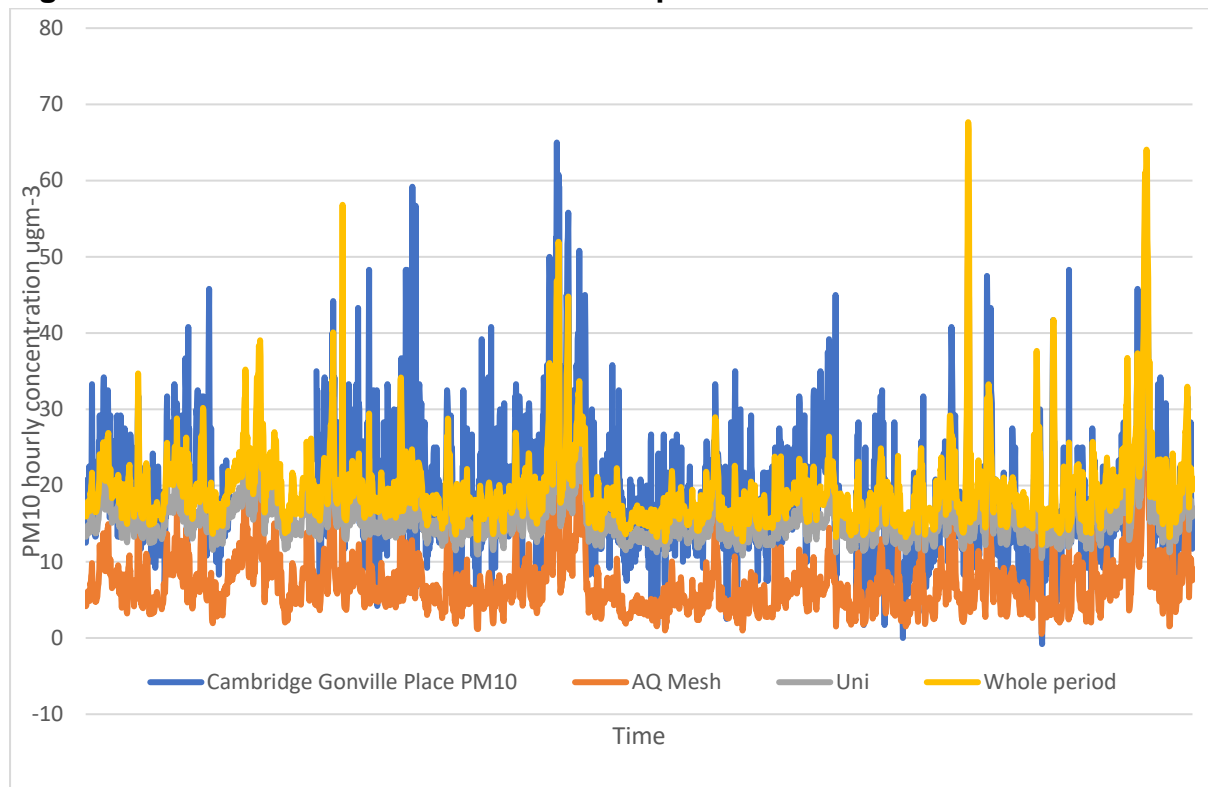
Figure B11 Calibrated AQ Mesh data comparison PM₁₀

The graph shows that the calibration methods reduce the offset observed between the AQ Mesh and the continuous monitor but do not improve the variability in measurements for the AQ Mesh. The use of the university method in some cases increase the values recorded to be considerably higher than the continuous monitor.

Based on the graph above we decided to use the whole period method.
